## East Kirk of St Nicholas dig - 24th to 28th April 2006 - Week 13

Judith Stones, Keeper of Archaeology, writes...

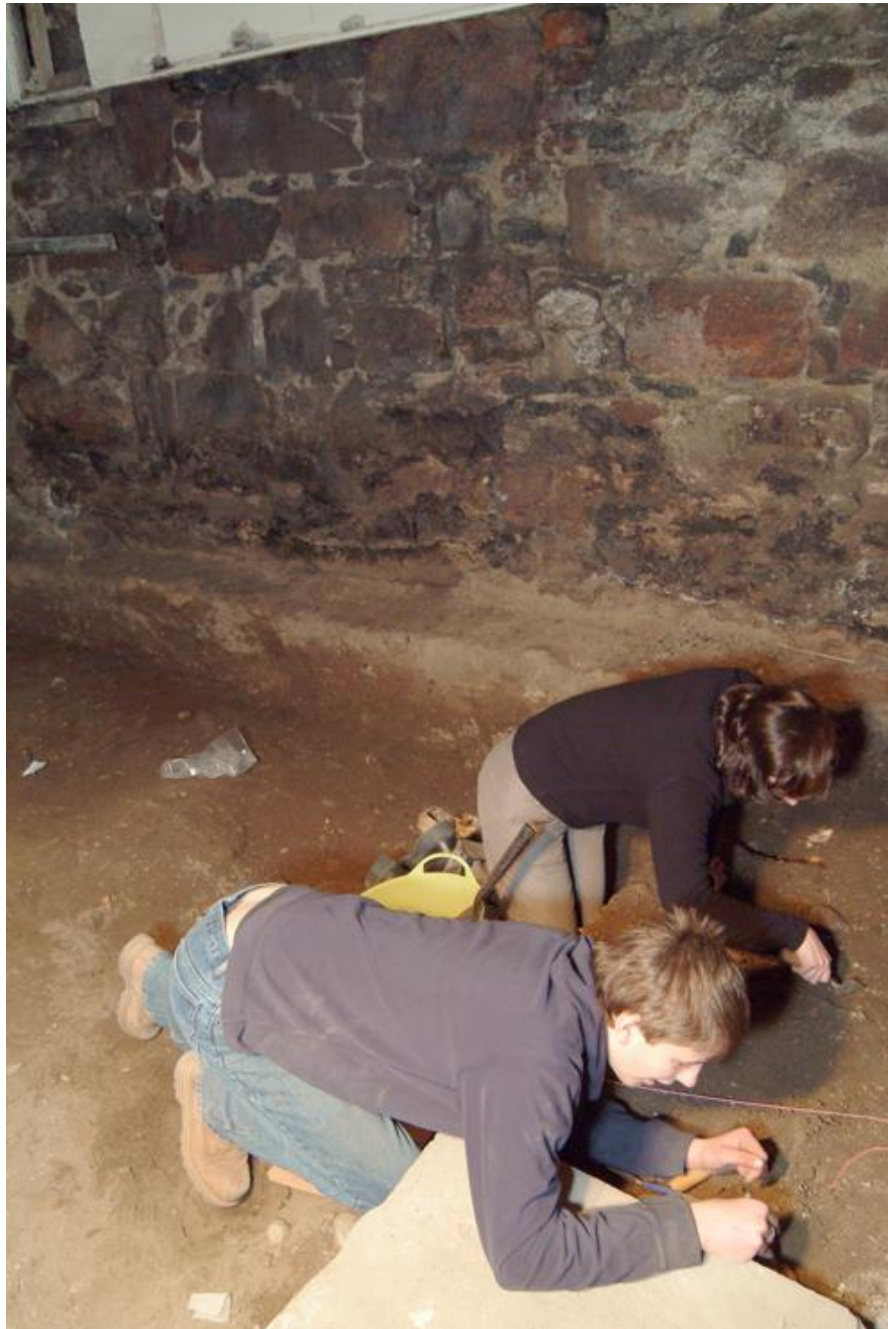
That impression is confirmed by evidence found on the dig. In the picture below you can see that the 19th-century wall behind David and Iraia looks blackened in places.

That must have happened during the fire, which shows that the 1837 East Kirk walls, although fire-scarred, were still structurally sound after the fire, and that re-building in that area was restricted to re-roofing and internal repairs.

In the first photo above, Iraia (to the rear) is taking great care to excavate the bones of a very tiny baby which had been buried in this area very near to the wall of the 15th-century church. Many children's skeletons have been found there.

David Watt, who you also see hard at work in the first photo, is a 16-year-old pupil at Meldrum Academy in Oldmeldrum, and was on his Easter holidays when this picture was taken.

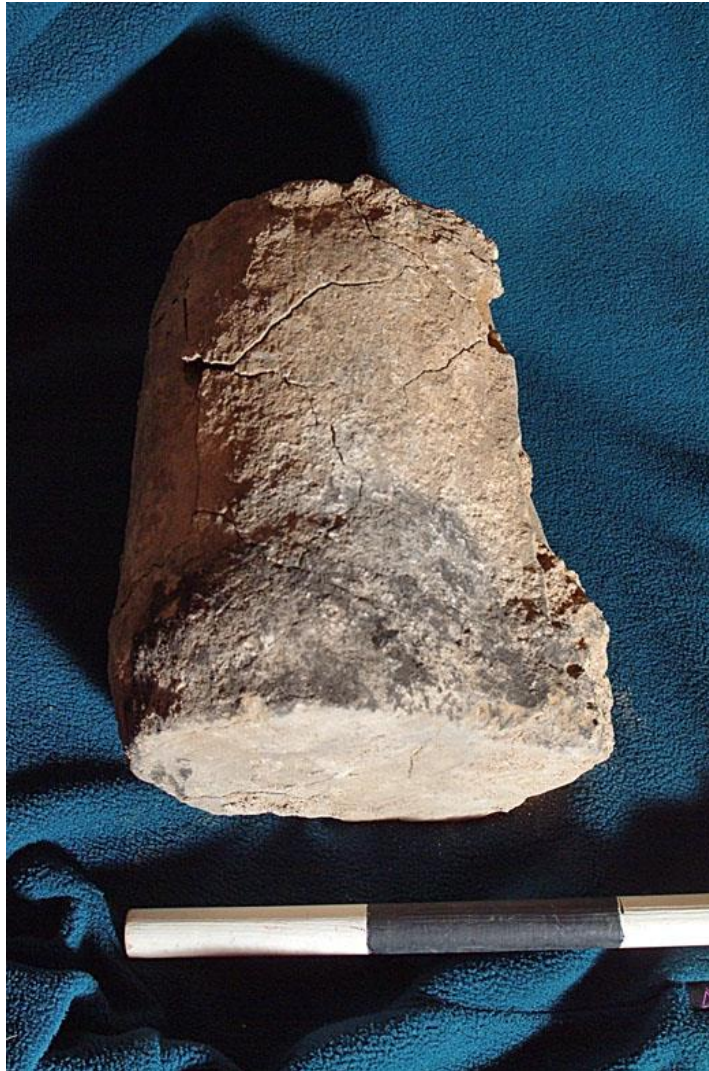
spire, built in 1507, and there's plenty of other archaeological evidence of it too, in the form of scorched and cracked stones, such as the one in the picture below.

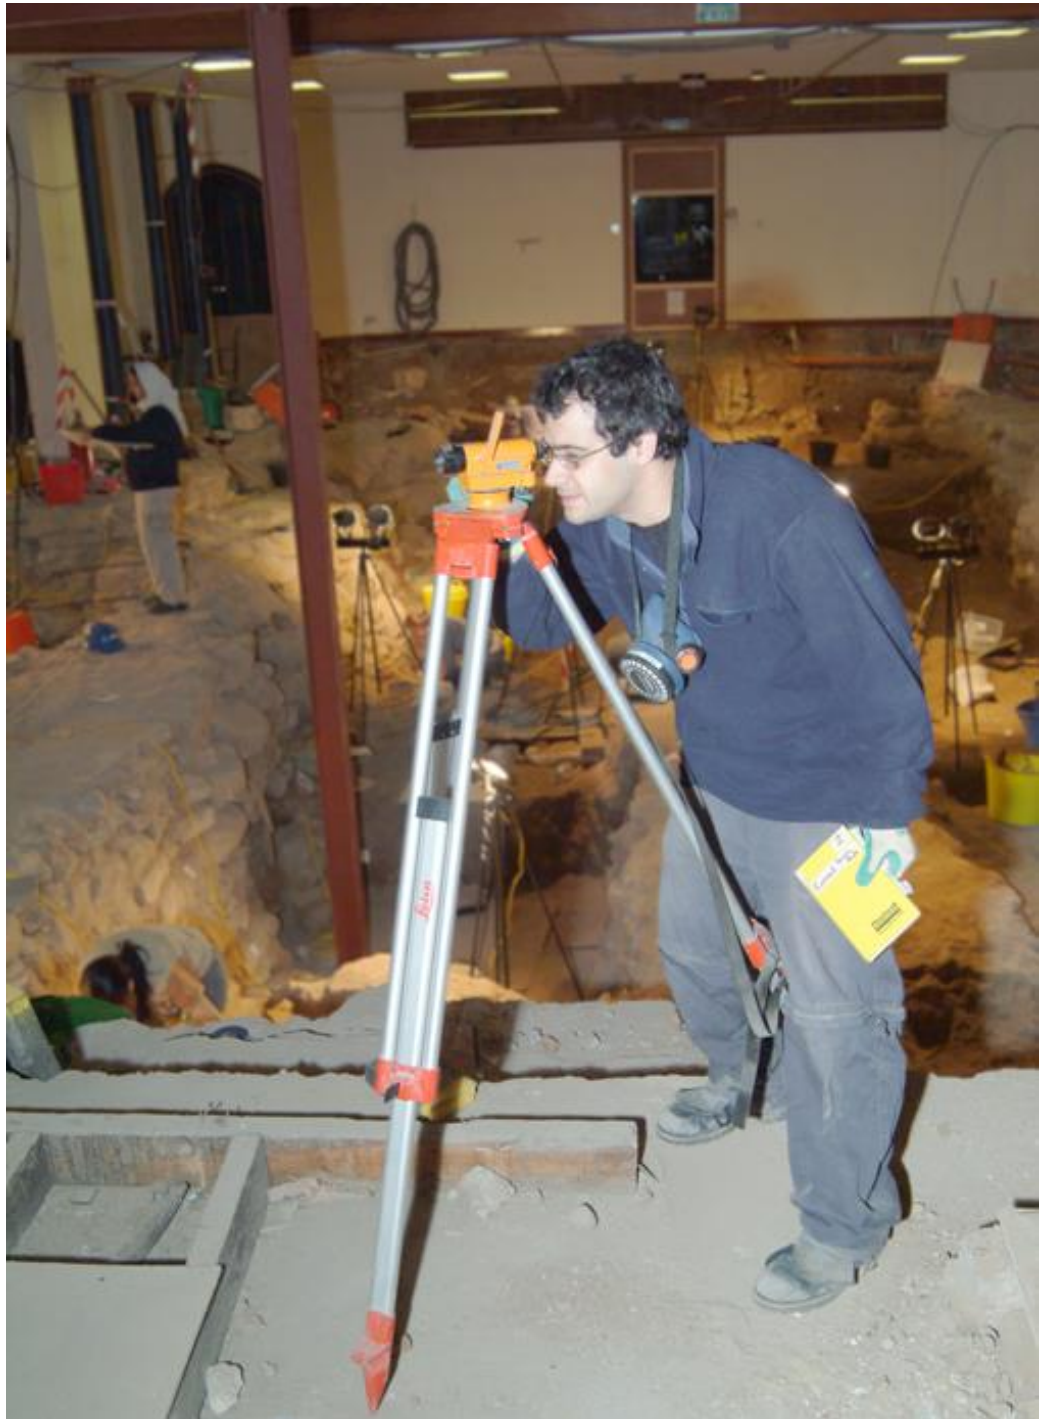
Farshid is seen below using a level to record some of the many thousands of spot-heights which will have been taken before the dig is over.

That might help to determine, for example, whether a tiny patch of mortar floor at one side of the church could have been laid at the same time a similar patch at the opposite side.

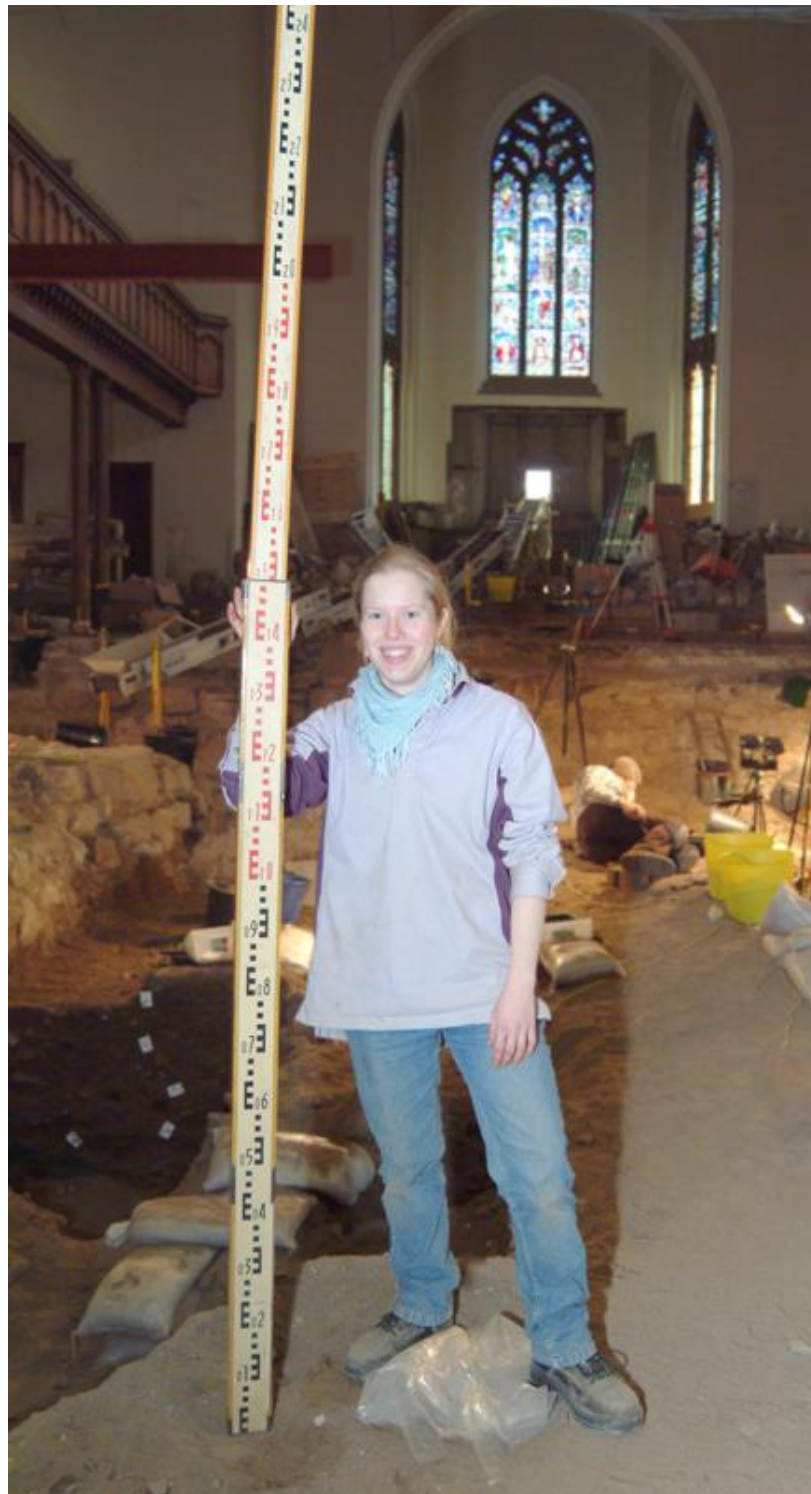
Maria is seen holding the levelling staff, calibrated in metres, on top of one of one of the wall foundations. In the background, to left of her, you can see some of the little white plastic labels which we use to mark different layers of soil, particularly when we're drawing sections.

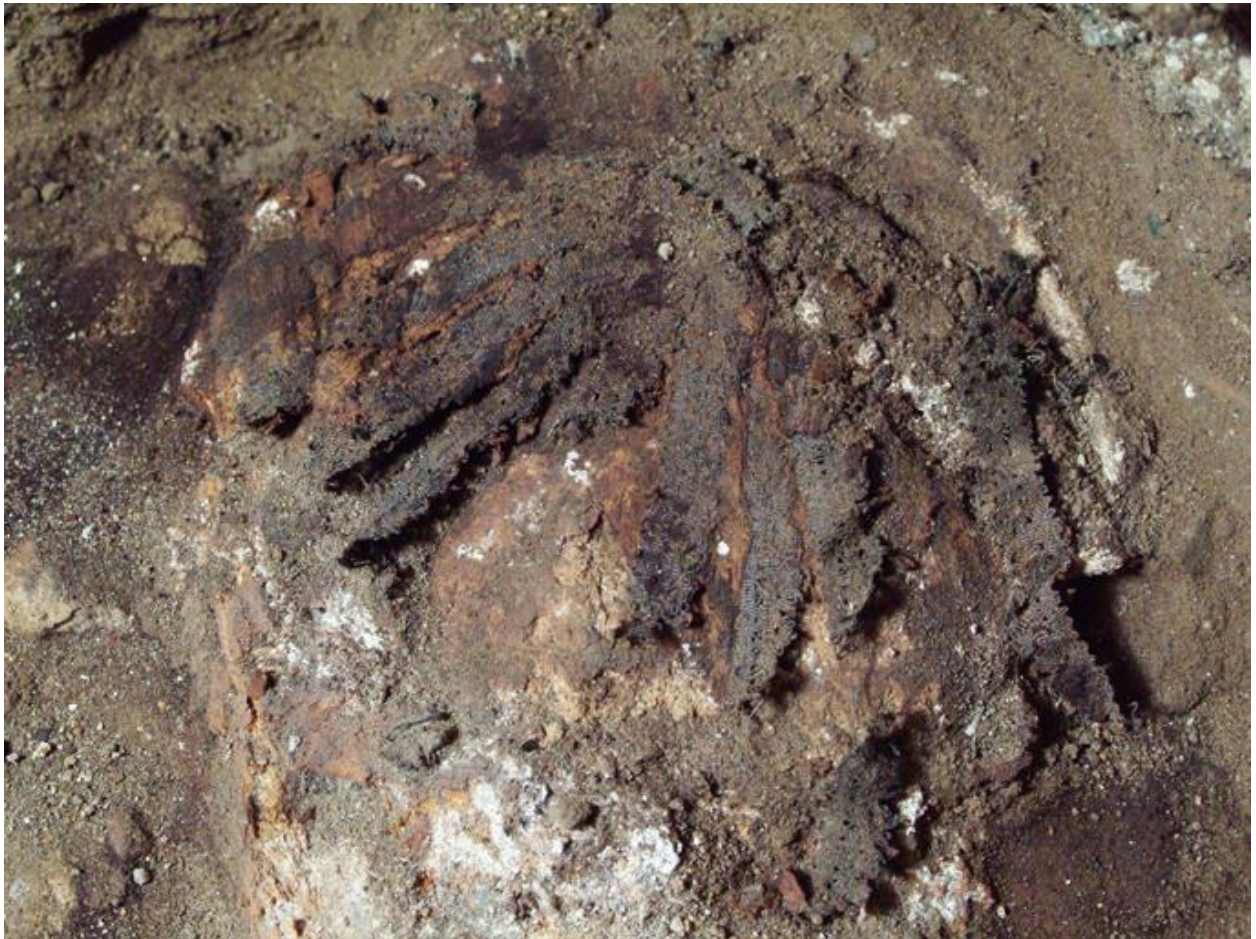
We're still finding burials which reveal clear details of how people were laid to rest in the past. At some point in the 17th or 18th-century, one person was buried in St Nicholas with very elaborate head-gear (pictured below), made of strips or ribbons of coarse silk, possibly held together or decorated with threads or laces.
